IMCA Safety Flash 12/19

May 2019

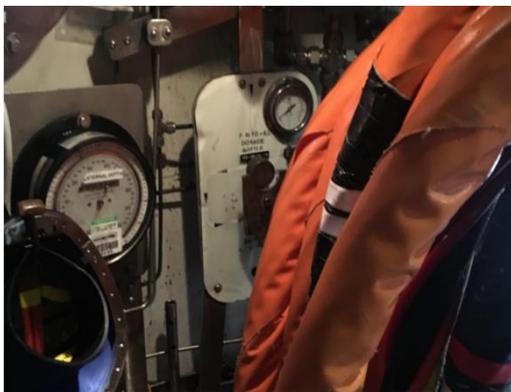
Location of panel

- ◆ Bell O₂ make-up was routinely performed by Bell divers;
- ◆ The oxygen panel was inconveniently located behind the diver #2 umbilical;
- ◆ The panel was capable of opening both valves at once, allowing the buffer bottle to be introduced into the bell, and into the main O₂ supply.

- ◆ Bell O₂ make up performed by life support technician (LST) by flushing with premix instead of bell divers adding O₂;
- ◆ Tubing was added to redirect Bell O₂ to near the saturation bell scrubber fan;
- ◆ The oxygen panel was moved 45cm from the old position, re-installed and the divers were given instruction on its operation;
- ◆ The new valve configuration – a sliding mechanism and the tight tolerance if the valve is opened - will remove the likelihood that both valves could be open at the same time;
- ◆ The buffer tank was changed from a single penetration to a double penetration, with valves top and bottom in lieu of a single in/out valve.

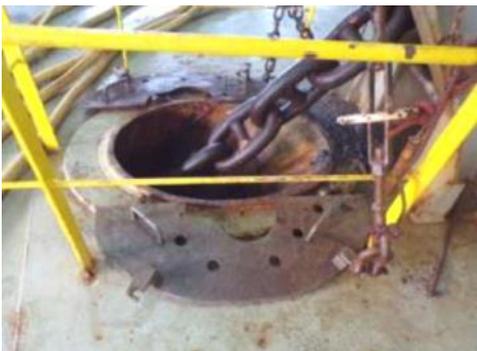
Hawse pipe cover securing (before)

- ◆ It was assumed that the intruders most likely boarding and leaving was via anchor chain and by dislodging a poorly fitted hawse pipe cover. Other boarding possibilities, e.g. ladder and rope and grapnel, appear difficult in this incident;
- ◆ The vessel confirmed maintaining anti-piracy watch, however, as watchkeepers monitored from the upper deck, it was inadequate for all parts of the vessel;
- ◆ Such thieves commonly use small, silent and unlit wooden boats, which are difficult to spot on the radar.

- ◆ Securing of hawse covering was upgraded to thwart such attempts;

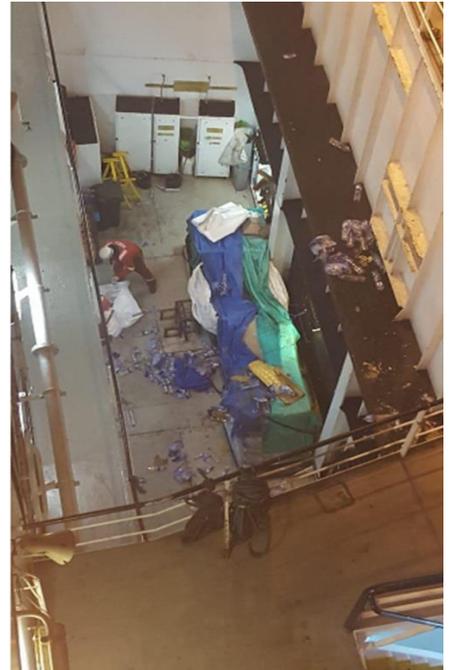
Riggers were attempting to lift a pallet of bottled water between decks of a vessel when the load hit an Intermediate Bulk Container (IBC), causing several packets of water bottles to fall from the load. The water bottles were in packs of 6 (weight per pack = 9kg) and fell approx. 11m. This was considered a potential fatality based on the DROPS calculator.

- ◆ The lift was arguably unnecessary; there were already two pallets of water bottles on the lower deck. Also, alternate means of conducting the lift were not considered;
- ◆ The risk assessment/lift plan did not specify a safe method of slinging the load to prevent water from dropping should it collide with vessel structure;
- ◆ The risk assessment/lift plan did not identify suitable control measures for the activity of lifting into this deck whilst at sea – there were numerous challenges for lifting operations due to restricted space and visibility, which were not taken into account.

- ◆ Review task risk assessments and lift plans for lifting of stores, to ensure hazards, controls, slinging and securing methods are suitable, clear and specific, and with due consideration to the specific controls required to reduce the likely probability of the event reoccurring;
- ◆ Review the requirement for and positioning of stores to minimise lifts to be carried out at sea, e.g. sufficient stores loaded alongside or on main deck.

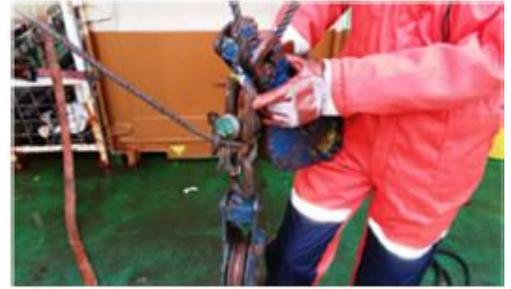
A hydraulic control lever on a console was inadvertently activated, resulting in the unplanned movement of part of the equipment on a drilling derrick on a vessel. A power swivel crept upwards making contact with a tagline connected to a sheave assembly, leading to a situation where equipment weighing 40kg was left suspended over crew.

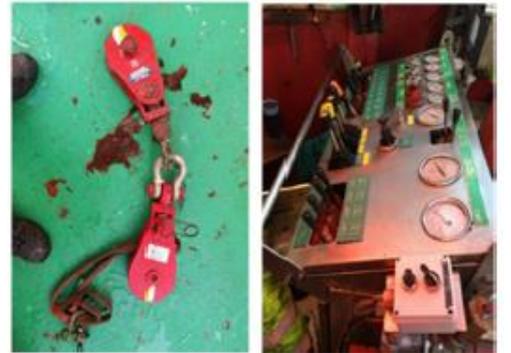
Investigation identified that the tagline's change in orientation caused the upper sheave to invert, resulting in the sheave's hinged gate to open. With the sheave gate open, an assembly with a combined mass of 40kg was left hanging on its winch wire above the manned working platform.

- ◆ It was concluded that the potential for unintended activation of the control lever(s) had not been adequately considered during the console's design;
- ◆ Once in service, lessons learned from similar incidents *had not been consistently applied* to all similar consoles;
- ◆ Poor situational awareness: crew failed to notice the uncontrolled rise of the power swivel – they were alerted by a member of crew positioned on the bridge who observed the power swivel making contact with the sheave assembly;
- ◆ Safe systems of work across departments with overlapping responsibilities for the inspection, supply, installation and use of the sheave assembly, had failed to identify the sheave's lack of a secondary restraint and subsequent DROPS risk.

- ◆ Review similar control panels and consoles to mitigate or remove risks arising from inadvertent activation of controls;
- ◆ Review and develop a common company standard for winch sheaves and their installation in the context of company operations;
- ◆ Improve visibility for workers involved in control locations for this kind of operation – e.g. through better use CCTV systems to better aid operator visibility;
- ◆ Review all operations where there is shared or overlapping business or project responsibility to ensure that task risk assessments and associated methodologies clearly define roles and responsibilities.

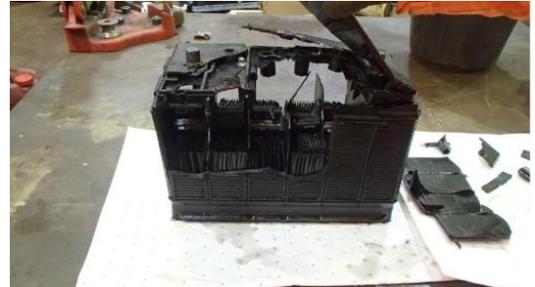
Weekly maintenance on a lifeboat involved charging the 12V starter battery, conducting voltage checks and starting the lifeboat engine. Following the charging and completion of voltage checks, the battery compartment hatch was closed, and the engine started. At this point the battery exploded. Pieces of the battery and fluid were expelled from the compartment having been partially restricted by the closed hatch lid.

- ◆ The battery installed was a wet cell lead/acid type, described by its manufacturer as ‘maintenance free’, although it could be topped up with distilled water. The model of battery was noted as not suitable for ‘installation inside the vehicle’;
- ◆ The battery had been overcharged weekly for over a year;
- ◆ Work instructions were not clear with regard to charging voltage levels required.

Overcharging caused a depletion of electrolyte within the battery and generation of an explosive mixture of hydrogen and oxygen gas. An internal electrical fault allowed for the ignition of this mixture upon start up.

- ◆ Ensure equipment is suitable for its intended use;
- ◆ Provide clear work instructions to avoid confusion;
- ◆ Ensure workforce has the correct core skills training/competency;
- ◆ Encourage the workforce to be assertive in and identifying and reporting operational discrepancies promptly to avoid inappropriate or unsafe conditions becoming the 'norm'.

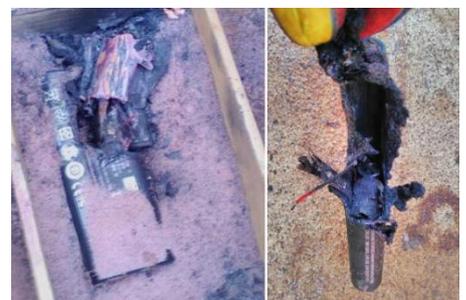
During a general fire alarm, a deluge system was activated and as a result, a piece of inspection equipment got soaked, causing the internal electronics to become saturated and short circuit. Afterwards, the lithium-ion battery was removed and found to be overheating. Shortly thereafter, the battery started to smoke, and then catch fire. Fortunately, the fire was controlled and extinguished immediately. However, the outcome could have been much worse.

The incident highlights the importance of protecting equipment from water ingress, along with the importance of ensuring that care is taken whenever equipment is being dried out following exposure to water.
