IMCA Safety Flash 14/19

June 2019

1 High Potential Near Miss: Person Found Unconscious in Confined Space

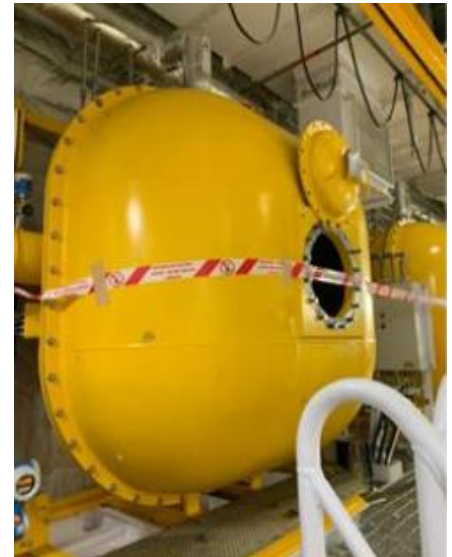
Pressure holding tests were being conducted, controlled from an interface cabinet. Nitrogen gas was used as the test medium. The pressure build-up was taking longer than usual so the vendor performing the test suspected that there was a leak somewhere. He heard a hissing sound coming from inside one of the GVUs (where the piping runs through) and suspected that the leak was coming from the piping inside the GVU. The vendor informed the commissioning engineer about the leakage and returned to the interface cabinet. Shortly afterwards the vendor noticed the commissioning engineer entering the GVU through the manhole opening. The vendor rushed to the GVU, but the commissioning engineer was already overcome by the nitrogen and had collapsed inside the unit.

- ◆ The gas valve unit (GVU) is clearly a confined space; however, the experienced engineer decided to enter alone via the manhole opening;
- ◆ There were no confined space entry controls in place at that particular GVU i.e.:
 - no confined space entry permit in place
 - no atmospheric test results at the location
 - no safety watch in place.

Never enter a confined space unless a permit is active, and all controls are in place to ensure your safety, such as; the atmosphere has been successfully tested; a safety watch is at the entrance; you know what the rescue plan is; and you have discussed your entry with your supervisor.

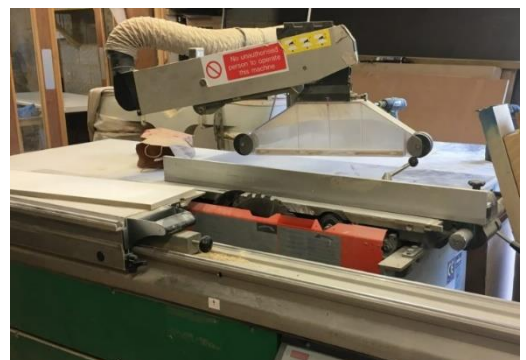
A company has been fined after two separate incidents led to workers' fingers being amputated. Employees were injured in two separate incidents involving cutting tools. One employee was injured while cutting timber on the blade of an unstable sliding table saw in August 2017 and suffered amputations to the middle and index fingers on his right hand. A second incident occurred in September 2018, when an apprentice joiner was feeding timber through a planer thicknesser and an insufficient guard caused the planer's blade to come into contact with the employee's finger, amputating it down to the first knuckle.

Investigation revealed that the company **had failed to ensure effective measures were taken to prevent access to dangerous parts of their machinery** (IMCA's emphasis). The UK HSE had issued the company with three improvement notices [*issued where an HSE inspector believes there is a serious breach of health and safety law, particularly one that poses a risk to people*] and a prohibition notice [*issued where an inspector believes that work activities give rise to a serious risk of personal injury. It normally requires you to stop unsafe work activity immediately*]. The company complied with the prohibition notice by making the sliding table saw stable but failed to comply with the improvement notices within the given deadline. A further extension to comply was granted, but again the company failed to do so.
