IMCA Safety Flash 15/19

June 2019

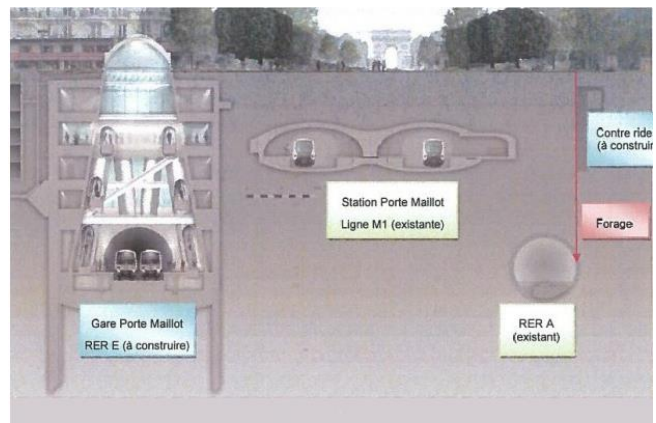
Le scénario d'un incident rarissime

- 1 LE FORAGE**
Lundi, dans le cadre des travaux Eole, un forage est réalisé pour analyser le sous-sol.
- 2 LA NAPPE PHRÉATIQUE**
Pendant sa descente, la tête de forage traverse une nappe d'eau souterraine située au-dessus de l'endroit où passe le RER.
- 3 UNE BRÈCHE DANS LE TUNNEL**
Vers 13 heures, la foreuse entre en contact avec le tunnel de circulation du RER A et y creuse un trou de 15 cm de diamètre. Les eaux chargées de boue de la nappe phréatique s'y engouffrent et inondent les voies.
- 4 LES CONSÉQUENCES SUR LE TRAFIC**
LA DÉFENSE-GRANDE-ARCHE, CH.-DE-GAILLE-ÉTOILE, AUBER, NANTERRE-PRÉFECTURE, CHÂTELET-LES HALLES. Tronçon fermé à la circulation.

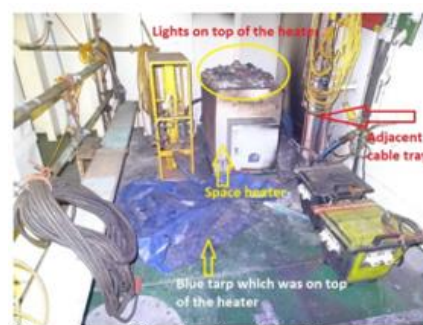
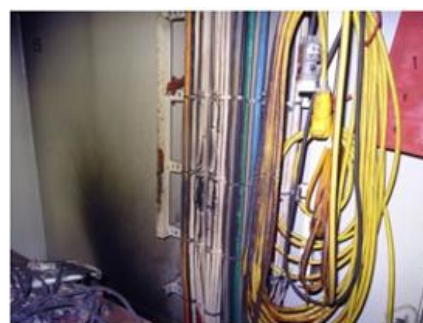
However, whilst washing activity in the first area was complete, the housekeeping was not. There were still three portable lights on top of the heater and it was still covered by tarpaulin. The three portable lights, tarpaulin and some adjacent electrical cables all caught fire.

- ◆ Assumptions: when the cleaning supervisor informed the electrician that the washing of the column was finished the electrician assumed that this included housekeeping;
- ◆ Didn't check: the electrician switched on power to the heater without physically verifying that the protection had been removed.

- ◆ CHECK! Always physically verify that worksites are returned to a safe condition after completion of work;
- ◆ Never ASSUME that the site is safe without making sure;
- ◆ Never re-energise equipment before making sure that it is safe to do so.

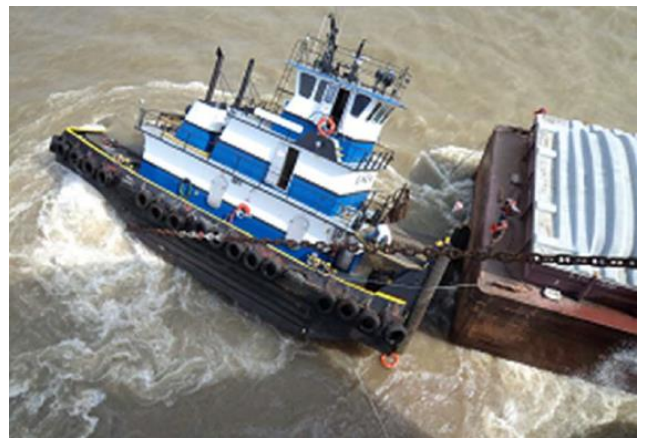
In all three cases *'towing vessels became pinned against another object in an aspect that exposed the vessel broadside to very strong currents.'* Once in that position, the vessels could not recover and sank.

- ◆ Avoid transiting between two anchored vessels, between two barge fleets, or between any other set of stationary objects;
- ◆ Minimize the number of operations which require the vessel to be positioned beam-to the current;
- ◆ Establish a minimum distance between the towing vessel and another vessel/object prior to conducting any operation that requires the vessel to be positioned beam-to the current;
- ◆ Recognize the risks involved in operating under high current conditions and weigh those risks before attempting to cross in front of stationary objects or attempting an operation that requires the vessel to be positioned beam-to the current.
