# IMCA Safety Flash 16/19

July 2019

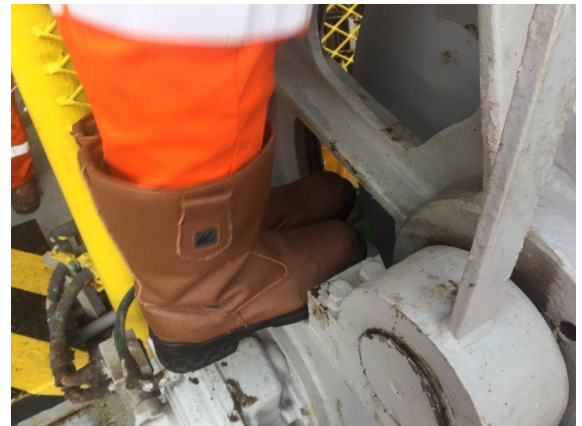
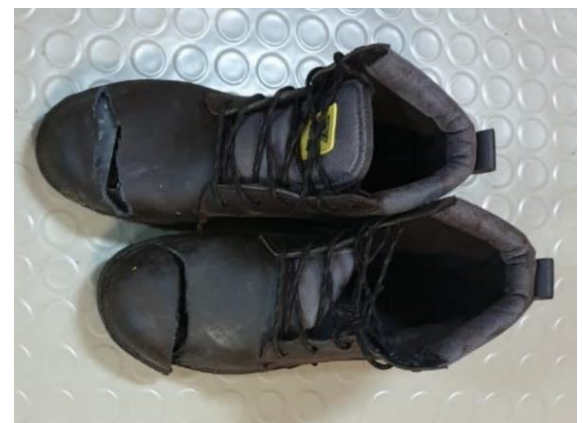
An AB was taking part in a task to re-spool a wire onto an aft deck tugger winch, when he climbed onto the side of the tugger winch and, whilst stood there, the rotating winch drum trapped both his feet. His injuries include a fractured foot and severe abrasions.

- ◆ The crewman failed to identify the hazards associated with the tugger winch;
- ◆ None of his colleagues intervened or told him to stop when they might easily have **STOPPED** the job' when he put himself in the line of fire;
- ◆ The risk assessment was inadequate – it did not include this particular hazard associated with the tugger winch.

- ◆ "Hazard hunt" focusing on winches and the hazards associated with them;
- ◆ Review of risk assessments related to deck operations to ensure that the hazards associated with winches are captured;
- ◆ Someone was injured because no-one intervened or stopped the job; remind all that it's OK to **STOP** the job if it's unsafe.

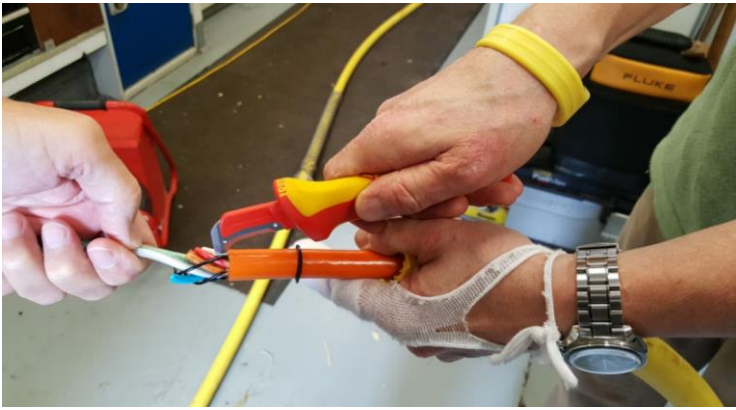
The immediate cause identified was that the injured person had failed to recognise that he had placed himself in the line of fire. He held the cable with his left hand and drew the knife (held in his right hand) towards himself. It was at this point that the knife slipped through the sheaving and made contact with his left index finger and left ring finger.

*Re-construction of the cutting activity*

- ◆ 'Engineer out' potential line of fire injuries; in this instance, alternative tooling and technique to be utilised for the removal of outer sheaving from a core conductor;
- ◆ Continue embedding the International Association of Oil & Gas Producers (IOGP) Life Saving Rules within the company processes and culture;
- ◆ Risk assessment should be suitable and sufficient for the task to be performed, specifying the correct tool(s) and PPE; the correct PPE should be readily available and used.

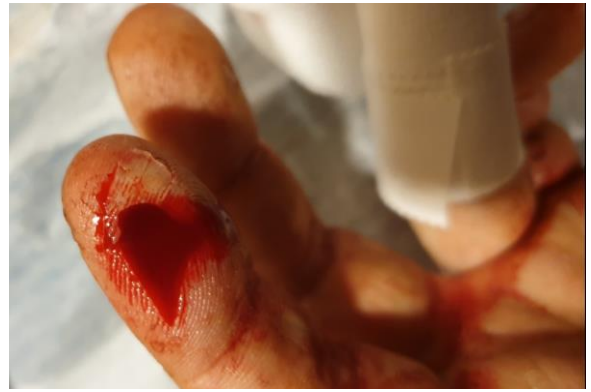
Whilst using a safety knife to remove the outer sheaving from a core conductor, a crew member managed to cut his finger. The safety knife slipped through the sheaving and resulted in a wound to the soft tissue of the fingerprint area of the left index finger, and a superficial laceration near the mid-point of his ring finger nail.

*The injury received to index finger*

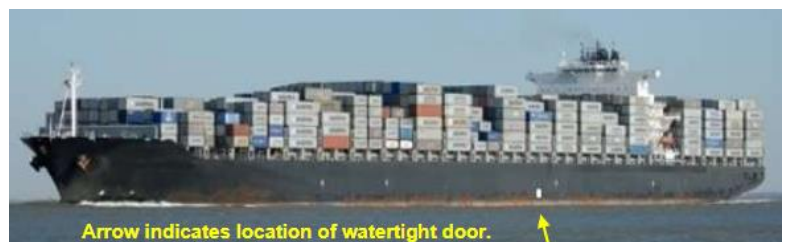
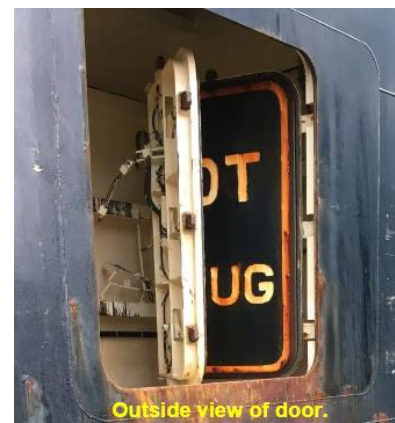
The US Coast Guard (USCG) has published [Safety Alert 05-19](#) relating to a man overboard fatality. The incident occurred when a very large (330m) container ship arrived in port in heavy weather (40 knot winds and 4m swell.) The vessel was on a WNW course with seas on the vessel's starboard quarter, manoeuvring at about 10 knots to make a lee in preparation to embark a ship's pilot at a port side hatch. Two crewmen were preparing for the pilot's arrival, behind the hydraulically operated bi-fold hatch door. This was located forward of the bridge and approximately 4m above the waterline – see photographs. As the vessel manoeuvred, it was hit by heavy seas that forced the hatch door open, resulting in flooding of the embarkation space, sweeping one crewman out to sea and injuring another.

- ♦ The two crewmen were unable to see the sea from their position behind the hatch door. As they opened the door, seas unexpectedly struck and violently forced it open, flooding the space;
- ♦ One of them was not wearing a harness or safety line, nor a personal flotation device and was washed overboard and subsequently swept out to sea.

- ♦ A thorough review and update of vessel Safety Management Systems (SMS), procedural manuals and guidance that relates to pilot transfers;
- ♦ Reinforce the importance of wearing personal protection devices and safety lines when working over the side of a vessel, when exposed to the elements or when there is an absence of barrier that could prevent an accidental water entry;
- ♦ Ensure officers and crew identify potential hazards and conduct a risk assessment, to include a consideration of weather conditions, prior to opening hatch doors of this sort;
- ♦ Ensure crew communications between navigation watch officers and crew, in situations such as this, are clear and provide suitable supervision of activities, considering sea state and other changing conditions.
