IMCA Safety Flash 18/19

July 2019

1 Important Safety Notice for Users of Crosby S-1326 18/20mm Shur-Loc Hook with 16t WLL – PN 100434

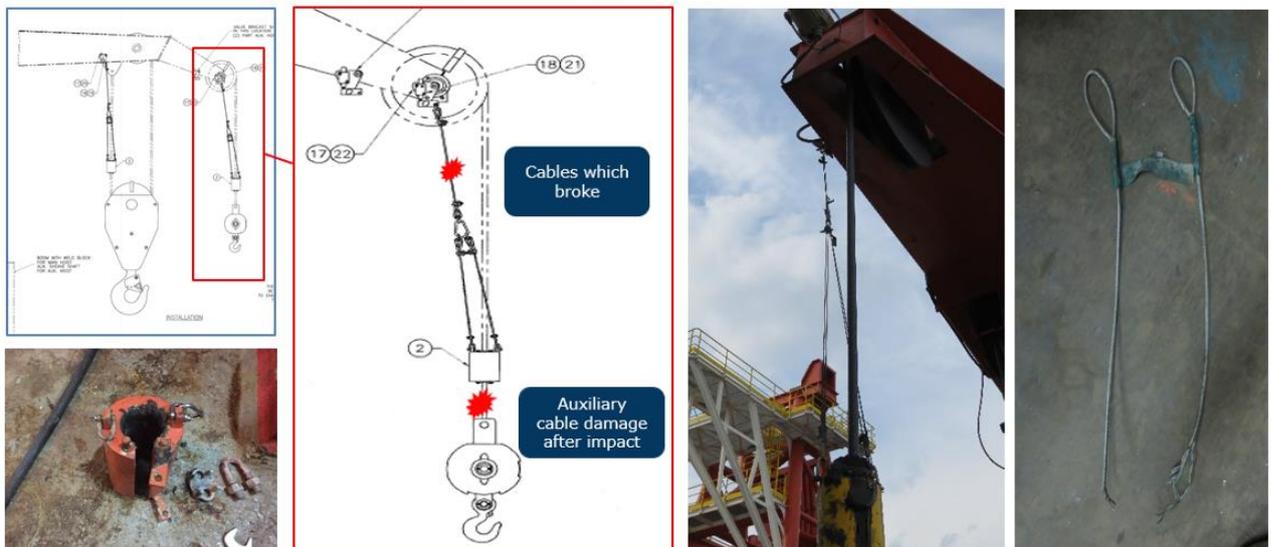
During routine lifting activities, a vessel crane's (auxiliary) anti-two block (A2B) suspension wires failed, causing the A2B weight assembly to fall along the crane wire to the crane block. Lifting operations were suspended and an inspection was conducted on the auxiliary crane wire and A2B system. No injuries to personnel were sustained as result of the incident.

- ◆ During inspection and function test of the A2B system, the actuation lever was found seized;
- ◆ Testing and inspection had not been carried out in accordance with equipment operating instructions;
- ◆ The crane operator's daily checklist noted 'testing' of the A2B system. However, it was found that only visual inspections were performed;
- ◆ The upper A2B suspension wires had parted at a position and in a fashion which suggested that the wires were severed by contact with the crane sheave and/or auxiliary wire. It is probable that the seized actuation lever prevented the A2B system from functioning correctly, allowing the crane block to pay-in past the 'cut off point', causing slack in the suspension wires and contact with the sheave.

A2B weight assembly

Crane auxiliary A2B system and components involved

Crane auxiliary A2B system near the sheave

Parted A2B suspension wires

- ◆ Full and thorough inspection of crane A2B systems to confirm that they are maintained, functioning correctly and free of potential seizing (of the actuation level);
- ◆ Inspection of equipment holdbacks/retention wires to identify potential for slack and/or entanglement with moving parts. Consider replacing wires with larger diameter;
- ◆ Always comply with equipment pre-start checklist requirements, including function testing of equipment where specified;
- ◆ Inspections should be appropriately documented to record subsequent findings/corrective actions, and records reviewed appropriately on a regular basis to verify effectiveness.

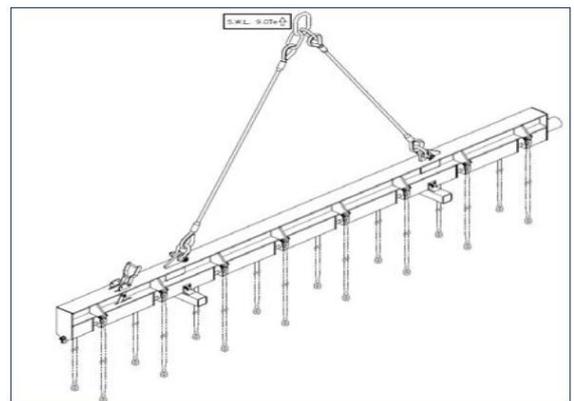
During subsea lifting operations with divers in the water, a large mattress lifting beam was lowered inappropriately close to the divers. The two saturation divers were deployed on the seabed at 156 msw, assisting with concrete mattress recovery using a mattress lifting beam attached to the vessel main crane. The beam weighed 696kg in seawater.

- ◆ Dive Team lost sight of the beam during descent, due to:
 - lack of due care and attention to load coming down
 - ROV was on seabed, and did not provide eyes on load from established short mark
 - poor visibility;
- ◆ Failure to stop the job:
 - acceptance of risk and failure to reassess the situation post-incident
 - failure to properly record and report events to management onboard at the time of the incident.

- ◆ Divers are clear of moving loads and maintain a safe distance at all times – not under the load nor in the 'DROPS cone of exposure';
- ◆ The divers can see the mattress beam and are in a position to control the lowering of the load by relaying instructions to the crane operator via the dive supervisor;
- ◆ There is an ROV to determine water depth and height of subsea assets, locate the mattress beam and confirm its status;
- ◆ The crane wire/lifting beam is fitted with mini beacon, light sticks, strobes etc as appropriate and is lowered to the 'short mark' above the assets or the seabed;
- ◆ The beam deployment is conducted at a minimum distance offset from client assets;
- ◆ The crane line out meter is zeroed when loads pass through waterline.
- ◆ Reaffirm requirements of company incident reporting process.

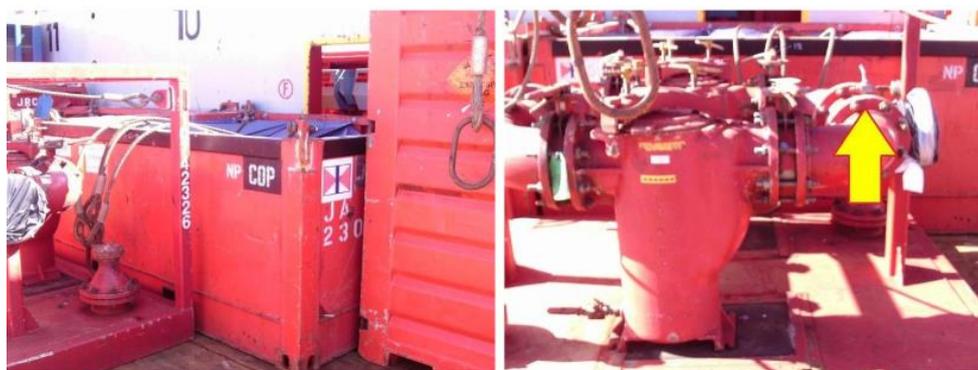
In the first incident, on a vessel engaged in offshore backloading operations, the lifted load came into contact with an adjacent lifted load on the same vessel. A part weighing 3kg detached from the load and fell to the deck.

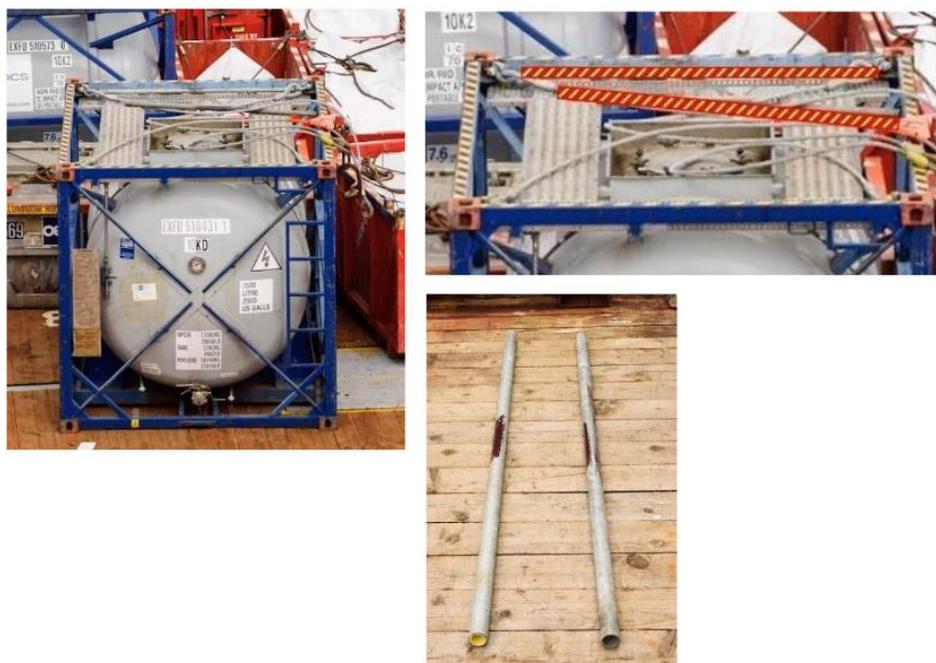
In the second incident on the same vessel at a different offshore installation, the crane operator noticed something on top of the lift after it had landing. He decided to retrieve the lift for further investigation but as it was hoisted, the movement caused one of the pieces to fall off the lift onto the deck. The vessel deck crew identified two scaffolding poles approximately 1.9m in length and weighing 10kg each.
