IMCA Safety Flash 20/19

August 2019

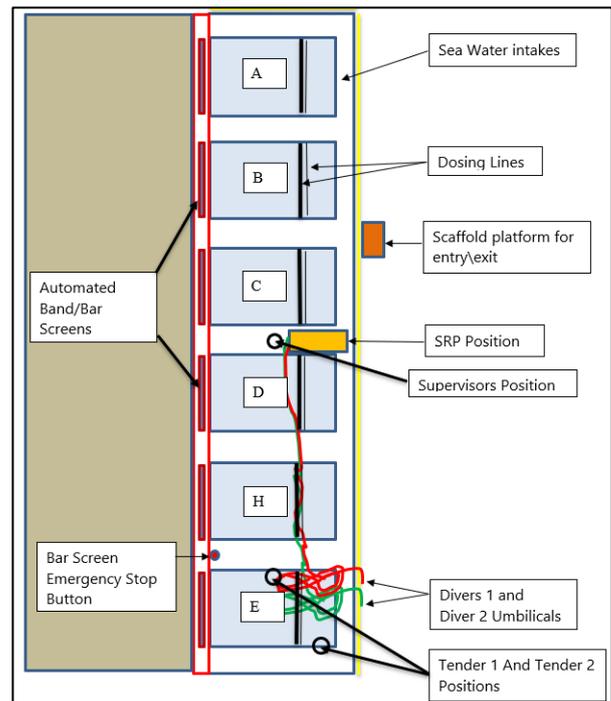
During near-shore diving operations, a divers' umbilical became trapped against a seawater intake. The dive team (2 x divers, 2 x tenders and dive supervisor) had completed a task and were busy recovering all the tools and rigging to recover to surface. Both tenders were receiving the tools from the water, and both diver's umbilicals were briefly secured to a railing. Diver 1 was looking for any tools left behind on the seabed when his excess (untendered) umbilical drifted into one of the seawater intake channels and lay against the screen. The automated bar started and Diver 1's umbilical became trapped. The rotating bar emergency stop button which was less than 10m away from dive control was immediately used by the dive supervisor. Diver 1 transferred onto his bailout and upon confirmation that the band screen was stopped, Diver 2 approached to assess the situation. The bar screen was manually turned in reverse, in order to free Diver 1's umbilical.

Onsite client personnel manually reversed the band screen direction before both divers returned to surface, and diving operations were suspended. There were no injuries sustained to either diver and upon inspection of the umbilical, there was a small perforation in the main airline approximately 11m from the helmet. The communications cable also sustained cut damage.

- ◆ Contributing factors:
 - diver umbilicals were tied off on the railing and were not being actively tendered; tenders were onsite but were engaged in other activities at the time (tender 1 was removing lifting gear and equipment from the crane hook, tender 2 was recovering tools using the messenger line)
 - seawater intakes were not isolated;
- ◆ Immediate causes:
 - there was no isolation of bar screens on the seawater intakes before diving began
 - umbilicals were not being actively tendered;

- Diver 1 failed to monitor his umbilical slack whilst he was engaged in recovering tools;
- ◆ Root causes:
 - inadequate engineered controls: failure to implement suitable equipment isolation
 - inadequate oversight or supervision.

- ◆ Thorough review and revision of risk assessment for this work;
- ◆ Revision of dive log requirements to include appropriate work planning and appropriate permit to work (PTW) requirements;
- ◆ Debrief and formal review by dive team, of method statement, dive plan and risk assessment, with particular reference to:
 - umbilical management
 - isolation of sea water intakes/band screens
 - are there enough people involved?
 - ‘last minute’ risk assessment
 - guarding against complacency and the hazards of ‘routine’ activities.

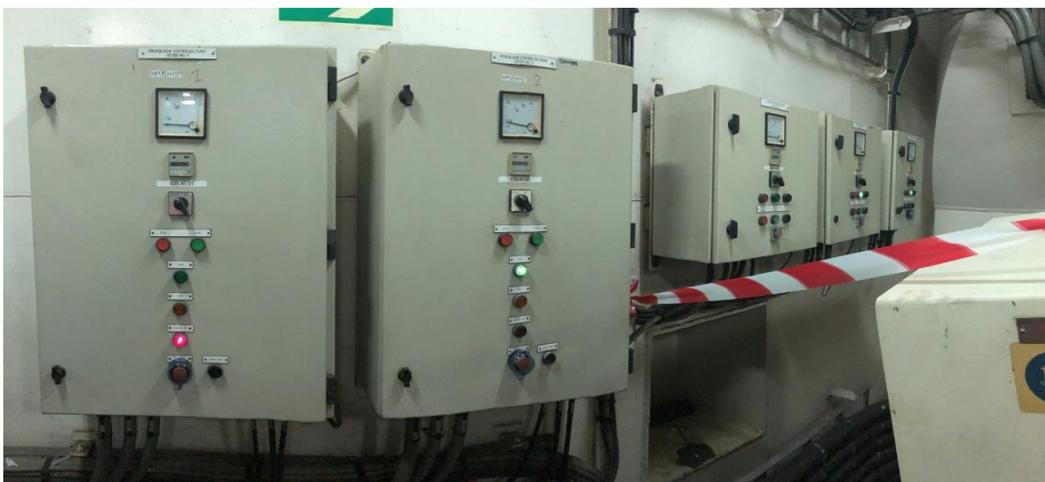
The VSP tripped out because both lube oil pumps stopped. Investigation revealed that the pumps were found to have stopped because both the emergency stop buttons for the pumps had been activated.

There were no protective covers on the emergency stop buttons. The buttons were inadvertently pressed by engine room crew lacking situational awareness. In this case, the control panels were located in a narrow access passageway.

- ◆ Improve situational awareness of all crew and improve/reiterate shipboard familiarisation;
- ◆ Be reminded of position of emergency stop buttons, especially in small alleyways or spaces where there are risks of accidental activation;
- ◆ Install covers on all emergency stop buttons;
- ◆ More thorough job safety analysis (JSA) and toolbox talks (TBT) to be carried out covering any routine maintenance activities in Engine spaces.

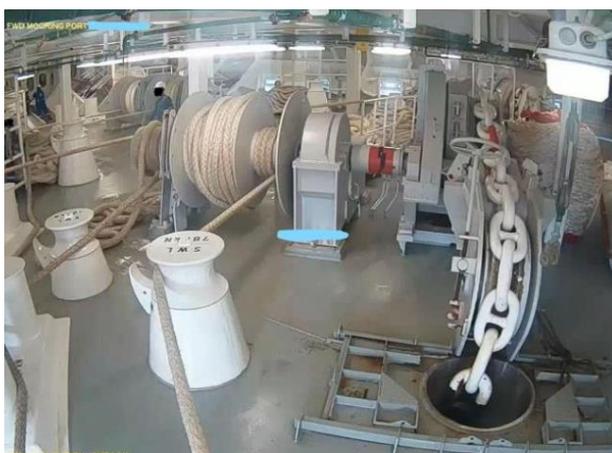
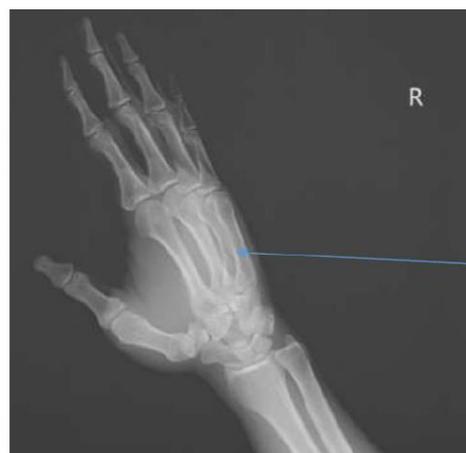
During mooring operations in the forward mooring deck of a large vessel, crew were in the process of sending out lines to line handlers ashore. When sending out the last breast line, they lost control and the line was slackened out in force. Despite shouted warnings to the contrary, the crewman closest to the line tried stopping it with his hands. The force of the line's movement resulted in a hairline fracture to his right hand. Medical treatment was given on-board before signing off the same day/port to recover from his injury.

- ◆ The force of the rapidly moving line was misjudged when deciding to attempt stopping it by hand;
- ◆ The mooring operations were being conducted without an officer in charge and with crew members lacking appropriate qualification requirements;
- ◆ The existing company procedures for mooring operations were neither followed nor enforced;
- ◆ The risk of events such as this occurring had not been assessed.

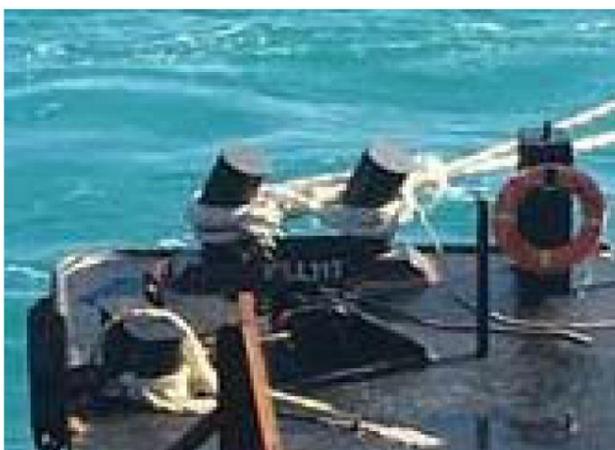
Incorrect mooring technique and pulling angle

- ◆ Incorrect mooring technique and pulling angle;
- ◆ The mooring lines were tied incorrectly to a bollard on the barge. The mooring configuration was not appropriate and allowed the mooring lines to slip off;

- ◆ The cargo barge bollards were angled ‘backward’ as they were designed for towing operations;
- ◆ The ‘attending’ tug had too much slack paid out on the towing bridle, and therefore attempts to abandon berthing operations were compromised.

- ◆ When mooring alongside a vessel, a ‘figure of eight’ mooring pattern should be applied to prevent the mooring lines from slipping off the barge if there is opposing movement possible between the tug and barge;
- ◆ Consider fit for purpose bollard design with appropriate mooring technique when mooring a tug to cargo barge. Marine inspections should take into account bollard design effectiveness for proposed operations;
- ◆ Further training and instruction for marine personnel involved, on mooring techniques and on line of fire positioning around mooring stations;
- ◆ Verify that contingency plans for marine operations are followed and regularly practiced.

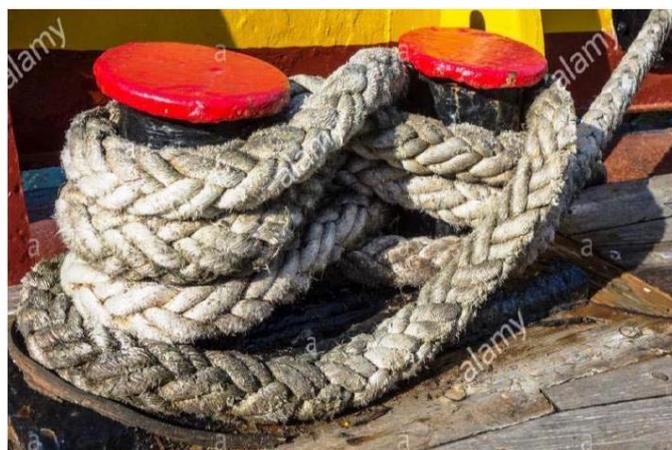
Example of correct mooring technique to prevent 'slipping off'

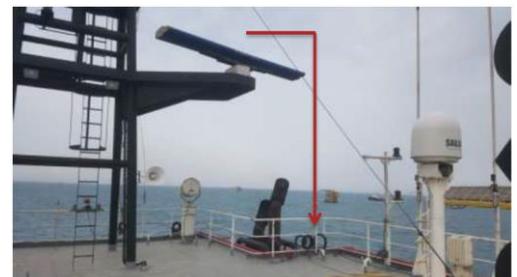
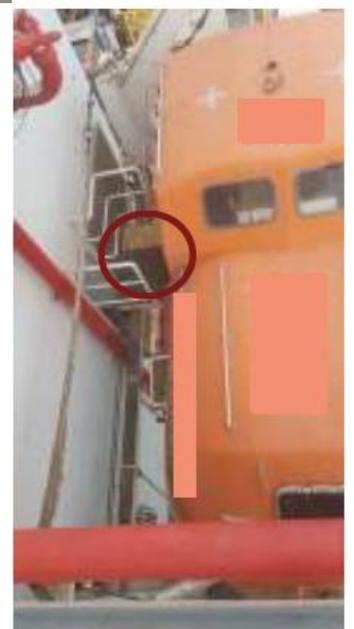
When he reached the monkey island, he couldn’t find the missing tool, and so he went to check on the mast itself. At that moment, the Captain and the second service engineer operated the radar for a final test. The radar antenna started to rotate and hit the service engineer. He lost balance and fell down from the mast to deck and landed on the roof of a fiberglass lifeboat. He suffered multiple fractures and was fortunate not to have been killed. He was medevaced to hospital for surgery.

- ◆ Poor communication and coordination;
- ◆ Poor management of subcontractors on the part of the vessel crew;

- ◆ Weak safety culture in subcontractor;
- ◆ Insufficient job preparation and completion of checklists.

- ◆ Better communication required: the vessel Master and second service engineer were not informed that the service engineer went back up onto the monkey island;
- ◆ Job preparation: more attention should be given to detail in preparation and to identification and mitigation of risks;
- ◆ Subcontractor management: better management and control of subcontractor required. Subcontractors should be more thoroughly monitored, especially when working in a dangerous area;
- ◆ Subcontractor selection: better selection should be made to focus on HSE aspects and to encourage subcontractors to improve their safety culture.
