IMCA Safety Flash 21/19

September 2019

1 High Potential Near Miss – Rescue Boat Davit Failure (MSF)

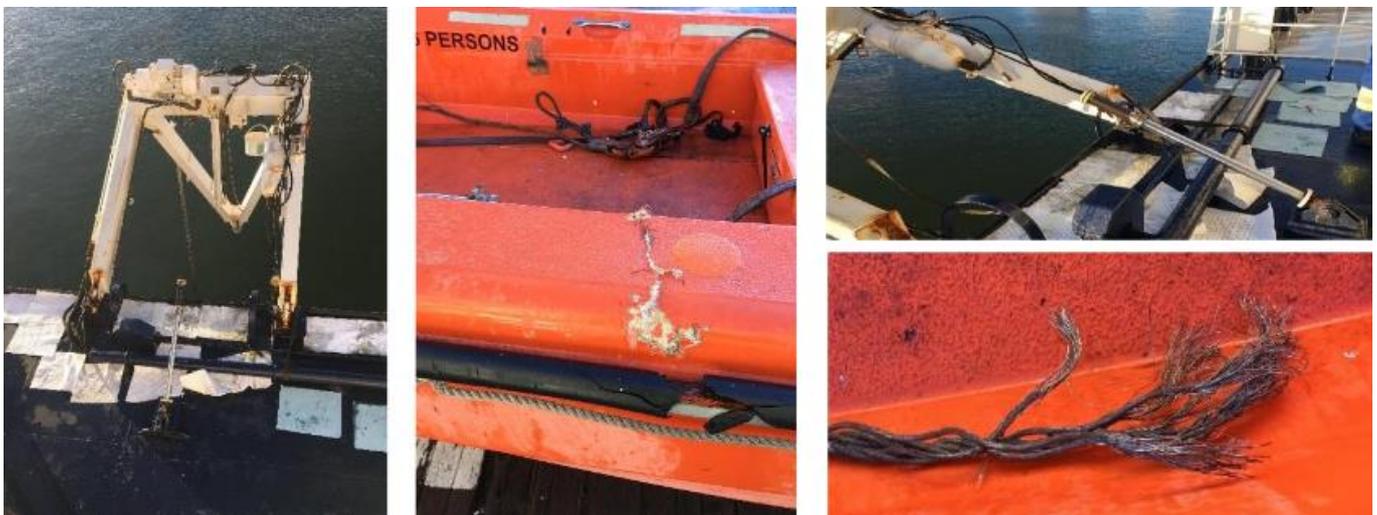
During the swinging out and lowering of the boat, the davit moved uncontrollably to the full extent of the piston, at which point the piston end cap separated from the piston and the davit carried on falling to the deck. On coming to a stop at the deck, the shock loading of the fall wire caused it to part and the rescue boat fell into the water.

The davit manufacturer and a local hydraulics expert were both unable to confirm the exact cause of the initial failure, however, a failure of one of the counterbalance valves or failure of the end cap itself were noted as the most probable first point of failure.

- ◆ The vessel owner made it mandatory for vessels to complete an unmanned test lowering of the davit and boat, function testing all controls, before conducting manned launch;

- ◆ Replacement of fall wires on rescue boats at 30-month intervals;
- ◆ At the five-yearly thorough examination, maintenance and testing of the rescue boat and davit, replacement of the counterbalance valves and piston end cap;
- ◆ Review of the maintenance and inspection requirements within vessel planned maintenance system (PMS) to ensure alignment with the manufacturer's recommendations.

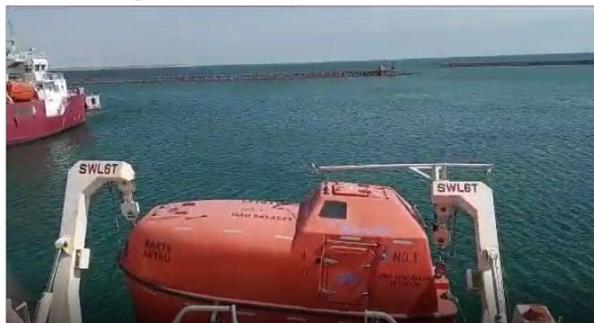
- ◆ During routine inspection of the rescue boat equipment and davit swing, it was noted that the davit would not swing out. This was due to a malfunctioning hydraulic pump not building up pressure;
- ◆ During a weekly technical inspection of lifeboats and davits, a delay in response of the aft davit was noticed whilst swinging in the starboard lifeboat to the stowed position. After a few unsuccessful attempts, the hydraulic accumulator valve of the forward davit was changed over to 'evacuation mode' in order to direct hydraulic oil to the hydraulic cylinder of the aft davit only. After that, the aft and forward davits came back to the stowed position at the same time.

- ◆ In both cases equipment failure.
- ◆ The faults were observed in routine planned inspections of the equipment, which emphasises the importance of conducting inspections and planned maintenance.

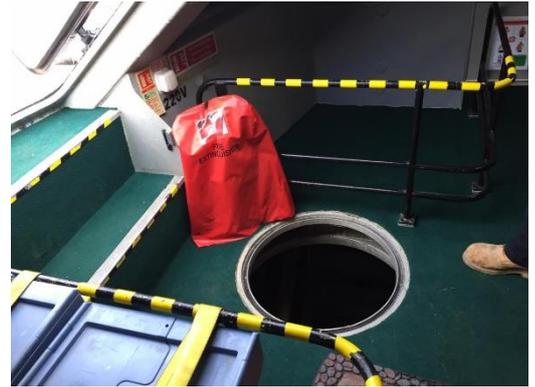
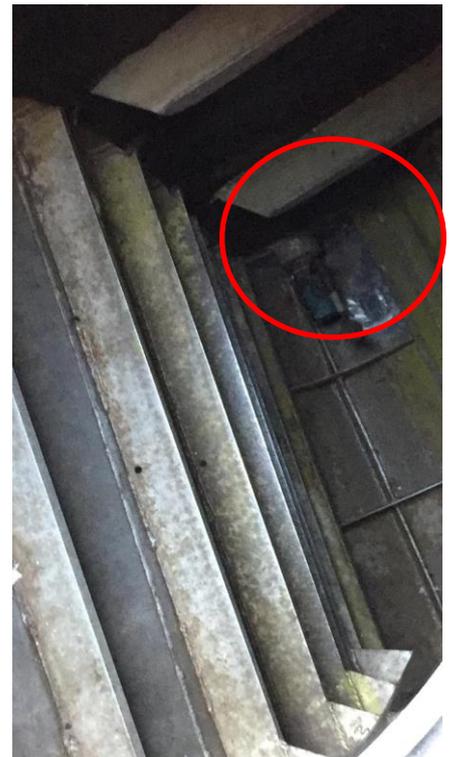
During her first voyage after drydocking, a crew boat started to list. A bilge alarm signal was received on the bridge, informing that there was water inside starboard side void space #1. Following this, starboard side void space #1 was checked and it was confirmed that there was water present. At the same time the Chief Engineer inspected the void space and observed that the main discharge non-return valve was not installed properly, and its gasket was not properly sealed. The other drain valve, placed between the forepeak and void space #1, was not installed at all and found lying nearby. The automatic bilge pump, which should have started immediately after the alarm was raised, had not started.

- ◆ The crew boat had been in drydock before this voyage; important matters were not noticed before the vessel was launched:
 - the non-return valve gasket in starboard side void space #1 was damaged
 - the valve in the bulkhead between starboard forepeak and starboard side void space #1, was not installed;
- ◆ The bilge alarm signal was only a flashing light and not an audible sound alarm;
- ◆ The automatic bilge pump, which should have started immediately after the alarm was raised, had not started because the control button on the panel was in the manual position, which prevented the system from starting.

There was no post-drydock maintenance inspection or dedicated testing to ensure that everything done in drydock was done properly and completely.

- ◆ Developed a pre-sail checklist of all and any critical equipment or systems (bilge systems, fire detection systems, alarms, navigation systems, propulsion and steering systems) to be checked as being in working condition before departure;
- ◆ Ensure equipment maintained, repaired or installed during drydock is physically checked and verified as working correctly.
