IMCA Safety Flash 22/19

September 2019

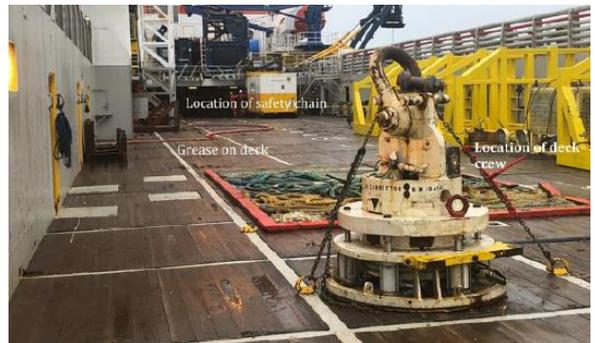
During crane operations on an offshore vessel, quantities of grease fell from the crane block and landed on deck. The incident occurred in daylight, when a wellhead head was landed into its frame on the starboard side main deck. Riggers were stood by in a safe area ready to work on the load, when the client representative (who was present) heard a 'splash' sound and noted grease lying on the deck directly below the crane block.

This was a near miss; there were no injuries.

The engine room crew greased the crane wire using the recommended greasing tool. The crew paid out the wire to 2800m, rinsed the wire and lubricated with the core lube pneumatic lubricator "Enviro X-433 EAL". 2 x 19l pails were used.

The increased water pressure, combined with the increased wire temperature, caused the grease to come out of wire (could be mixture of original grease and the newly applied grease).

The crane manual does not provide a recommendation on the amount of grease to apply to the wire.

- ◆ Crane operations were stopped; the crane was racked and cleaned of excess grease;
- ◆ Crane pre-use checklist and toolbox talk (TBT) to include dropped grease hazard, both updated to include potential dropped objects and highlight potential for falling grease;
- ◆ Visual inspections on the accumulation points and removing excess grease.

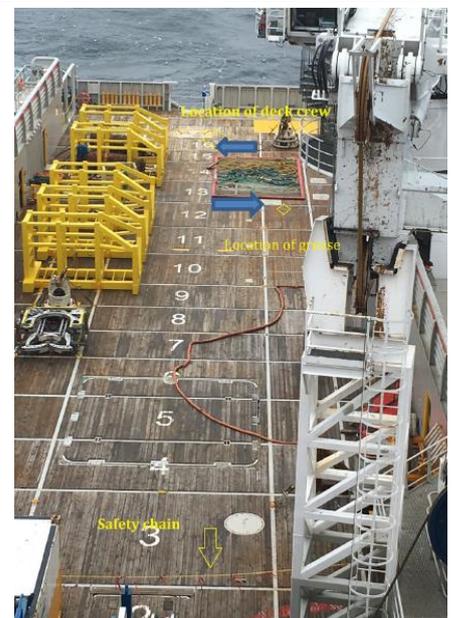
- ◆ Although classified as a liquid, crane grease is slightly viscous (between solid and liquid) and once a certain amount accumulates, it will drop to a lower level;

- ◆ Accumulation points are mainly the chandelier and sheave;
- ◆ Crane wire grease should be considered a dropped object;
- ◆ A **'dropped object'** is any item that falls from its previous position.

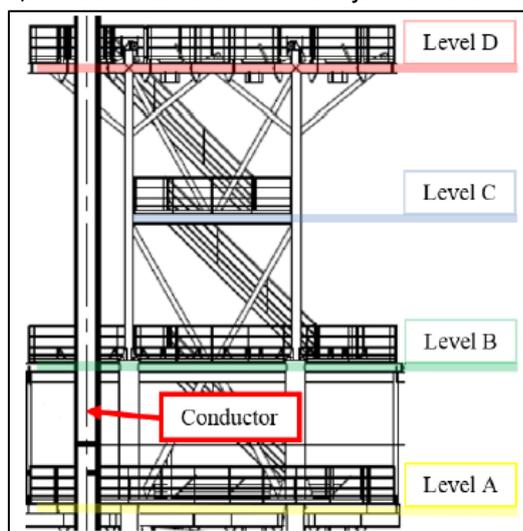
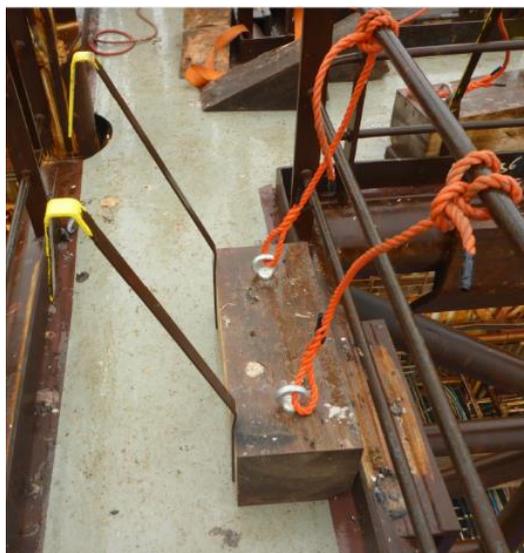
During a decommissioning project, a wooden wedge, weighing approximately 13 kg, dropped 6m, striking a rigger's hard hat and shoulder on its way down. The rigger suffered minor cuts; it was fortunate that his injuries were not more serious. The incident occurred during decommissioning operations using a conductor support frame (CSF) to help with the removal of conductors. Conductors were pulled into position in the CSF by crane. To reduce horizontal movements, wooden wedges were installed, whilst the conductors were being cut in smaller sections. During removal of the wedges, one of the wedges fell and struck the rigger.

As per company procedure, the wedges were to be placed into position at level B, to remove any horizontal movements of the conductor. To reduce movements from the top of the conductor, additional wedges were installed at level D (top level) of the CSF; *this addition was not part of any procedure.*

After completion of the sectioning cut at level A, the rigging team started to remove the wedges installed at level B, as per original procedure. Whilst removing the wedges at level B, one of the wedges installed at level D dropped to level B striking one of the riggers.

- ◆ Procedures had not been updated to include the additional wedges at level D;
- ◆ Management of change (MoC) was not implemented/followed;
- ◆ There was a failure of the wedge securing eyes due to vertical movement of the conductors caused by vessel/platform movement;

- ◆ It was not identified that removal of the (upper) level D wedges prior to removal of the (lower) level B wedges would have eliminated the dropped object risk.

- ◆ Any change to a procedure should be subject to MoC;
- ◆ Procedures should be updated immediately and re-issued to include any changes;
- ◆ Any changes to procedures should be communicated to all personnel potentially affected by the change;
- ◆ All persons involved should take part in risk assessments/job safety analysis (JSA) in order to ensure all hazards are identified and eliminated/controlled.

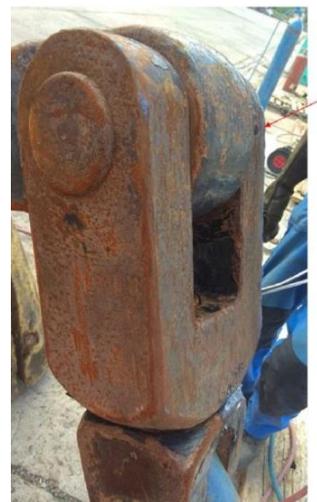
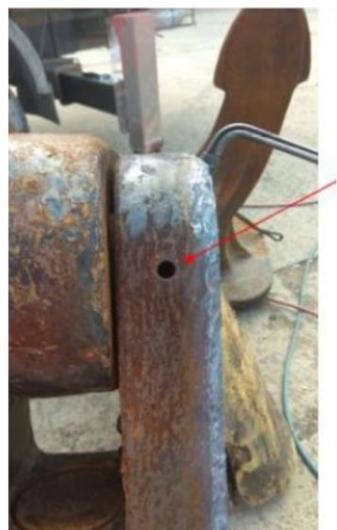
During planned modernization of the stern anchor it was discovered that the safety pin in the anchor's swivel shackle was absent.

There was no regular planned maintenance scheduled for this piece of equipment. The condition and availability of the anchor swivel safety pin was not the part of the planned maintenance program; thus, it had not been checked periodically.

- ◆ A new safety pin was ordered and installed in the shackle within 12 hours;
- ◆ Conduct immediate additional full inspection and check condition of anchor swivel's shackle and availability of safety pin;
- ◆ Ensure that planned maintenance system (PMS) requires regular planned maintenance of anchoring equipment, including a check that the safety pin is in place and in good condition.

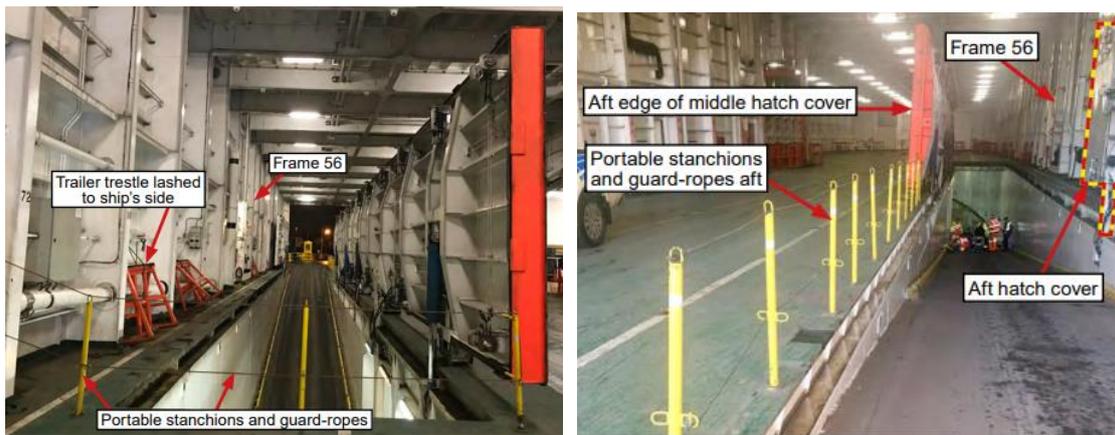
The UK Marine Accident Investigation Branch (MAIB) has published accident [Investigation Report 9/19](#) into a fatal fall from height. A crewman from the Cypriot registered ro-ro freight vessel *Seatruck Pace* died as a result of 4.5 metres fall through a vehicle ramp hatch.

The crewman was working alone and preparing to paint the leading edge of the open ramp hatch cover. For reasons that could not be determined, the crewman crossed a temporary safety barrier guarding the edge of the open hatch and walked along a narrow deck edge between the ship's side and the open hatch on which several trailer trestles were stowed. The crewman's fall was not witnessed but it is evident that he had fallen at or about the same time as one of the trestles. He was treated at the scene before being taken to hospital. He died three days later.

- ◆ The crewman crossed a safety barrier protecting an open hatch;
- ◆ Risk seen as tolerable – the risk of falling was accepted, having probably taken similar risks in the past;
- ◆ Work practices indicated that adherence to the vessel's safety procedures was based on routine rather than of understanding and conviction.

- ◆ Reminded Masters of the dangers of bypassing safety control measures and prompted them to review the safety of deck openings;
- ◆ Provided safety chains, fittings and warning signs for use on the temporary barriers rigged on the main vehicle decks of its ferries;

- ◆ Reviewed its risk assessment and permit to work (PTW) concerning working at height;
- ◆ Introduced a procedure for recording the use of safety harnesses;

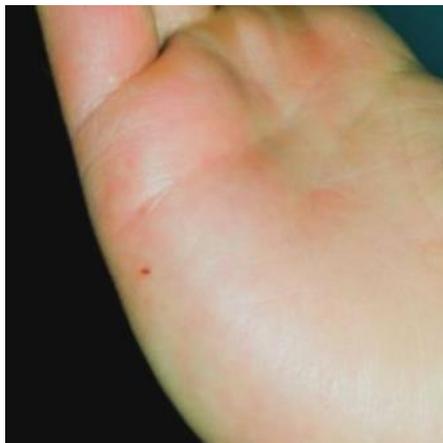
A firefighter whose hand was amputated after he was injured by faulty cutting gear has received £1.5m in damages. He was working with hydraulic cutting equipment on a training exercise when his hand was pierced by a high-pressure jet of hydraulic fluid. See <https://www.bbc.co.uk/news/uk-scotland-48599963>.

The hose pipe connecting the hydraulic pump (which worked at up to 850 bar of pressure) to the cutting gear was riddled with tiny punctures which can appear over time after the hose has been dragged over broken glass or metal shards at the scene of an incident. One of these punctures caused a fine jet of hydraulic fluid to escape and pierce the leather safety gloves worn by the injured person.
