IMCA Safety Flash 12/19

May 2019

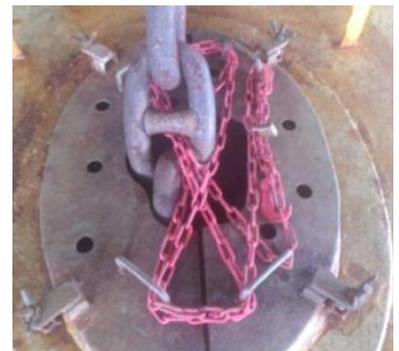
Hawse pipe cover securing (after)

- ◆ It was assumed that the intruders most likely boarding and leaving was via anchor chain and by dislodging a poorly fitted hawse pipe cover. Other boarding possibilities, e.g. ladder and rope and grapnel, appear difficult in this incident;
- ◆ The vessel confirmed maintaining anti-piracy watch, however, as watchkeepers monitored from the upper deck, it was inadequate for all parts of the vessel;
- ◆ Such thieves commonly use small, silent and unlit wooden boats, which are difficult to spot on the radar.

- ◆ Vessel security patrol arrangement was amended to include precautions and routines for forepeak surveillance;
- ◆ Reinforced bosun store skylight and door securing arrangements;
- ◆ Ensured mooring spaces are maintained clear of all items that may be used as tools by thieves;
- ◆ Stowed all loose mooring ropes, heaving lines and messengers inside bosun store at piracy prone anchorages/waiting areas;
- ◆ Be seen to display vigilance, e.g. flashing high beam torches over-side, use of Aldis lamp or search lamp sweeps and security patrol blowing whistles.
