# IMCA Safety Flash 16/19

July 2019

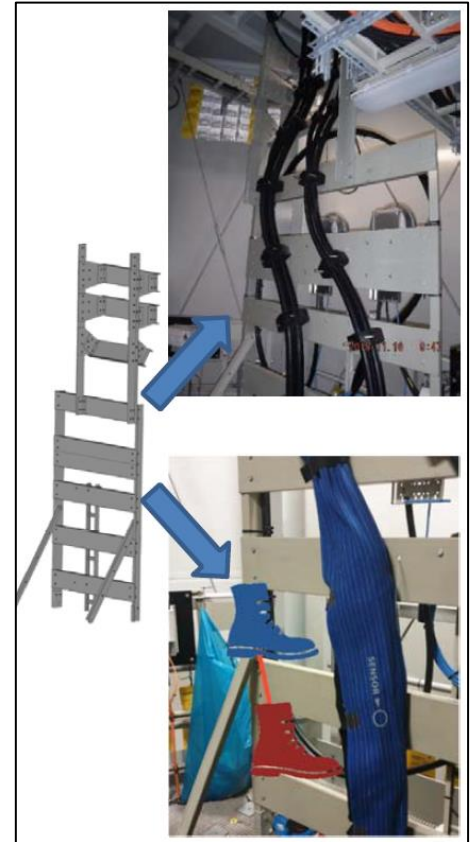
The immediate cause identified was that the injured person had failed to recognise that he had placed himself in the line of fire. He held the cable with his left hand and drew the knife (held in his right hand) towards himself. It was at this point that the knife slipped through the sheaving and made contact with his left index finger and left ring finger.

*Re-construction of the cutting activity*
